**NASA Contractor Report 178409**

## **Composite Transport Wing Technology Development**

Douglas Aircraft Company  
McDonnell Douglas Corporation  
Long Beach, CA 90846

**Contract NAS1-17970  
February 1988**

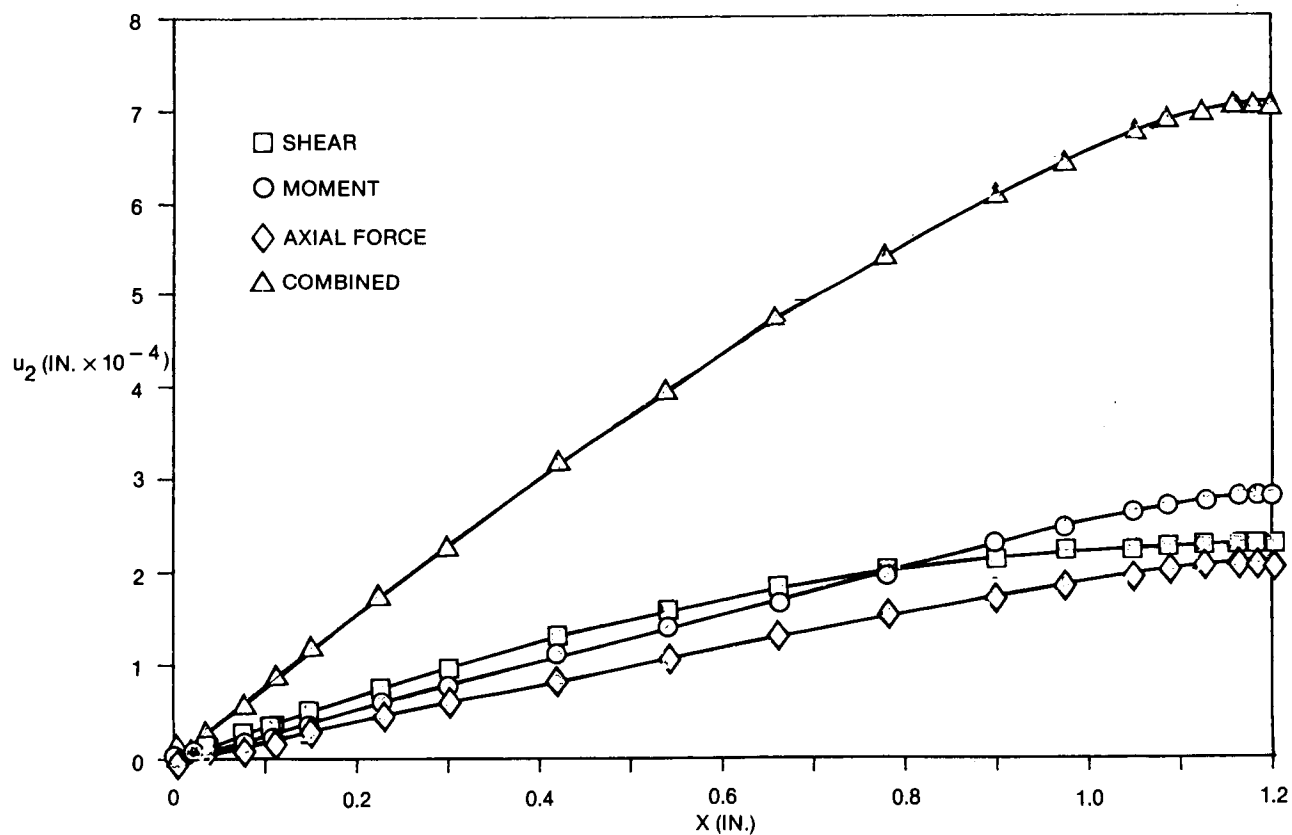
Figure 45. Axial Displacement of Flange (Lower Plate)

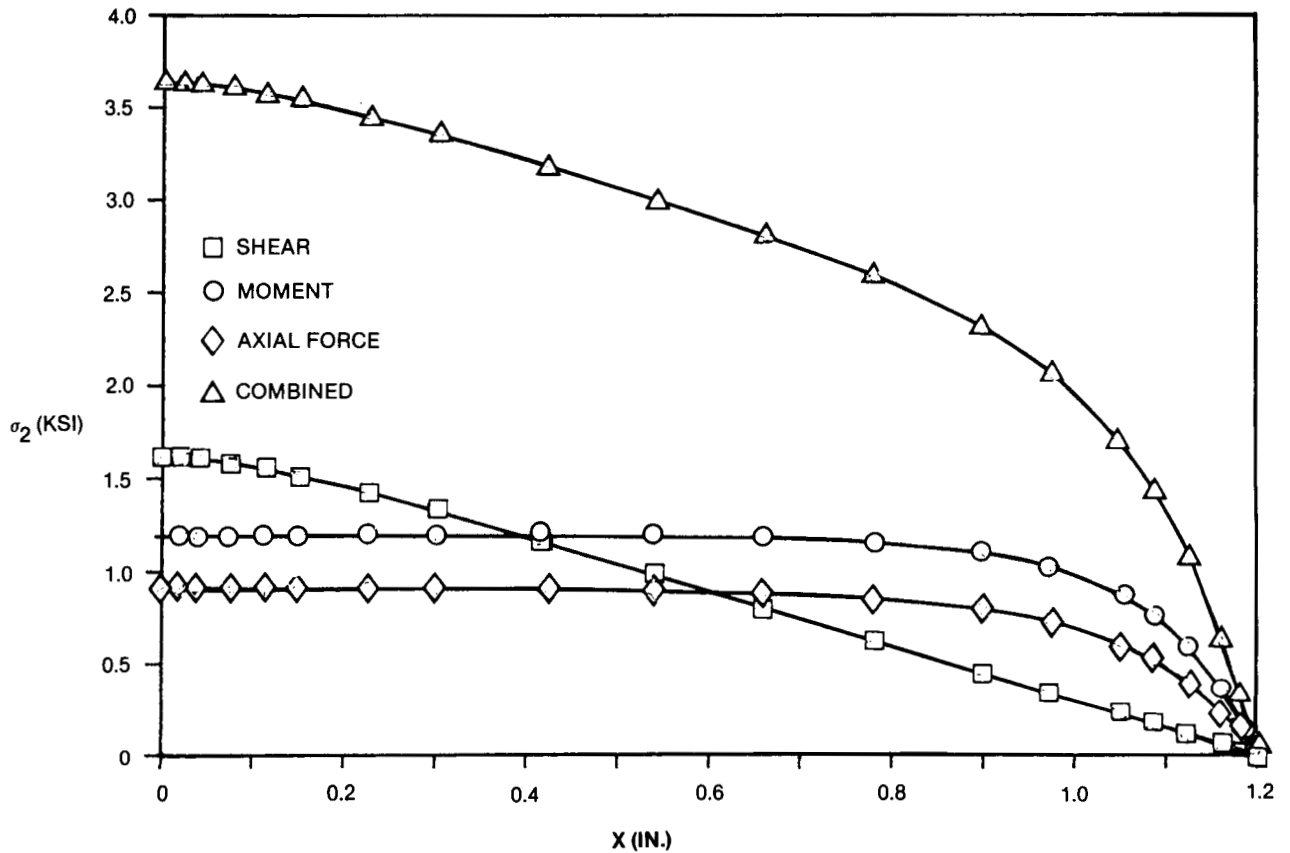
Figure 46. Axial Stress in Flange (Lower Plate)

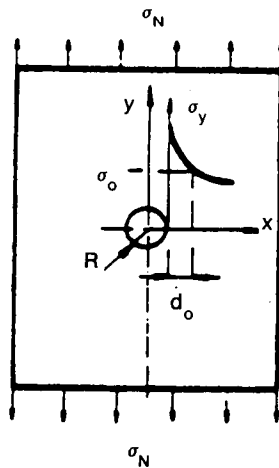
**Figure 47. Axial Stress Distribution for a Plate with a Hole and Characteristic Length,  $d_o$  (Point Stress Criterion)**

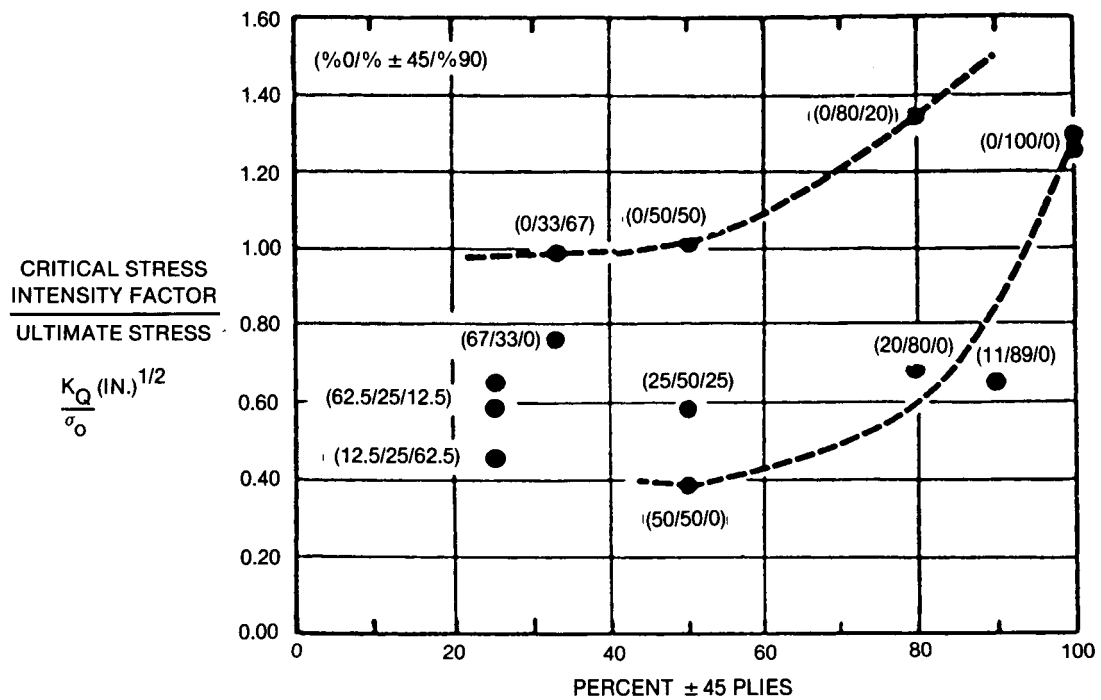
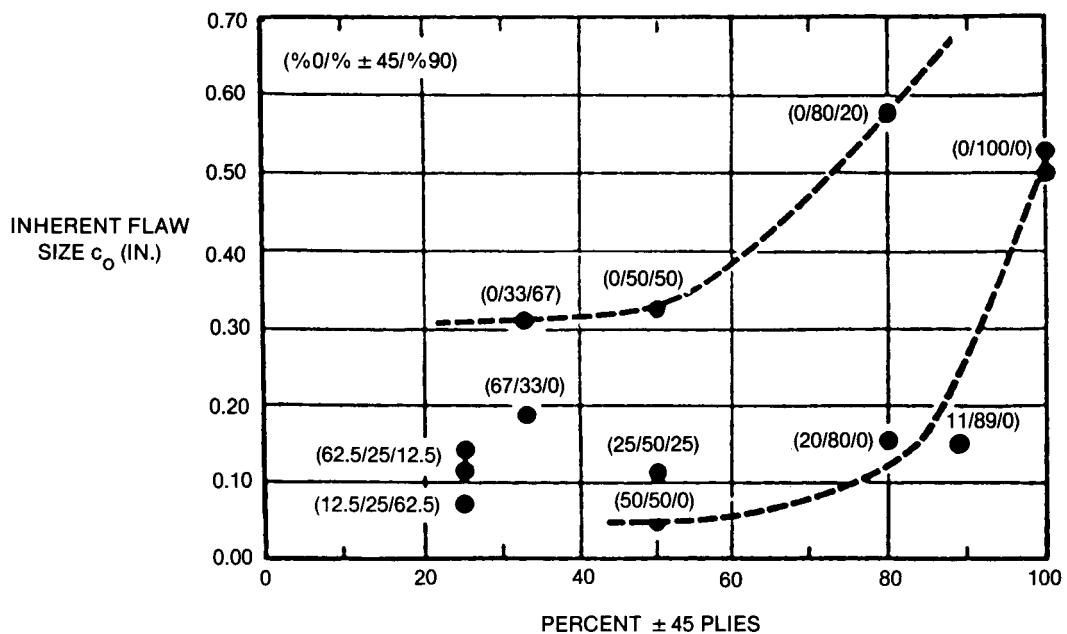
Figure 48. Critical Stress Intensity Factor and Inherent Flaw Size,  $c_o$ , for Different Laminates

Critical stress intensity factor,  $K_Q$ , and inherent flaw size,  $c_o$ , for different laminates for carbon-epoxy systems (Reference 15) are shown in Figure 48.

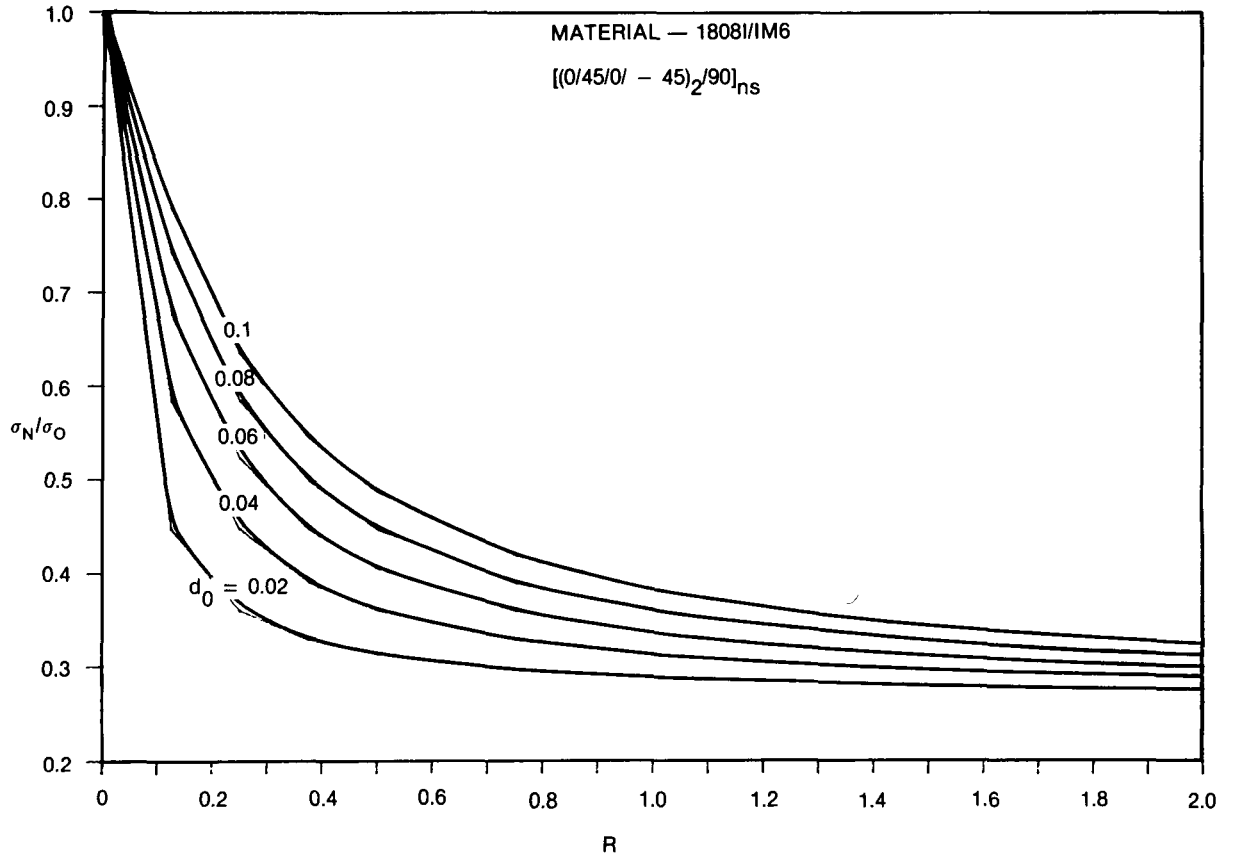
**Figure 49. Residual Stress Distribution Versus Damage Size for Various Values of  $d_0$  (Point Stress Criteria) at  $K_T = 3.5$**

The residual strength of laminate  $(0/45/0/-45/90/0/45/0/-45)_{3S}$  is plotted in Figure 49 for material 1808I/IM6 with  $K_T$  equal to 3.5 for different  $d_o$  values.

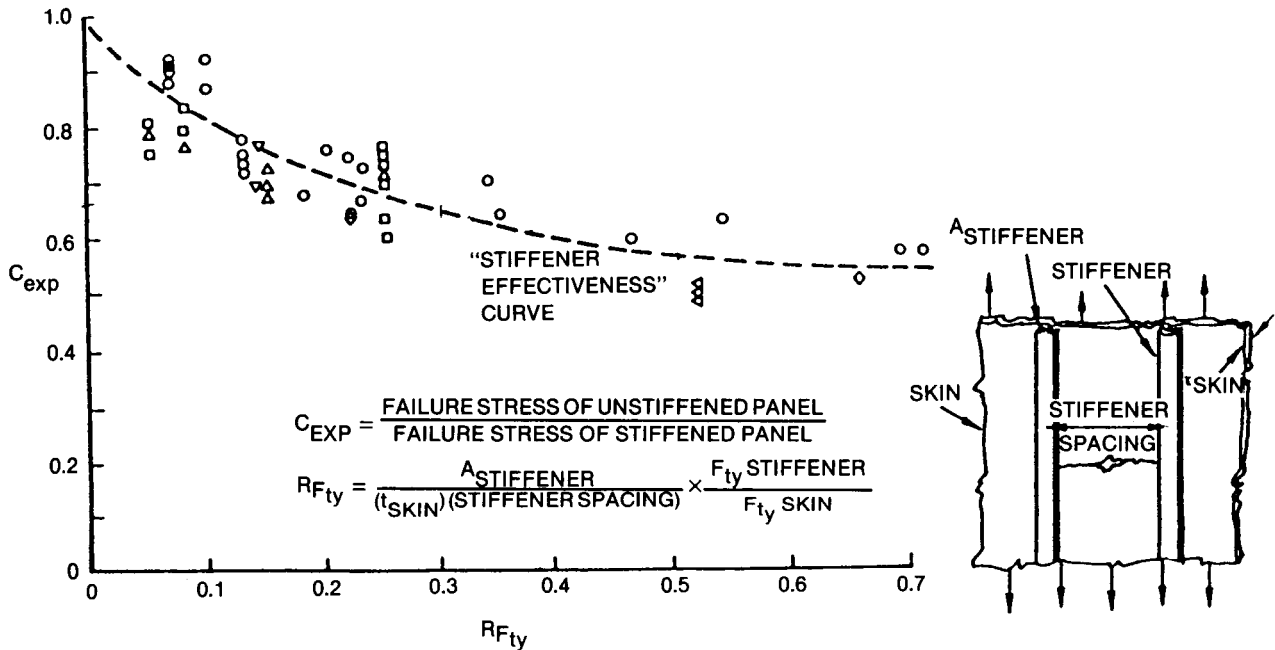
Figure 50. Stress Distribution for Stiffened Panel

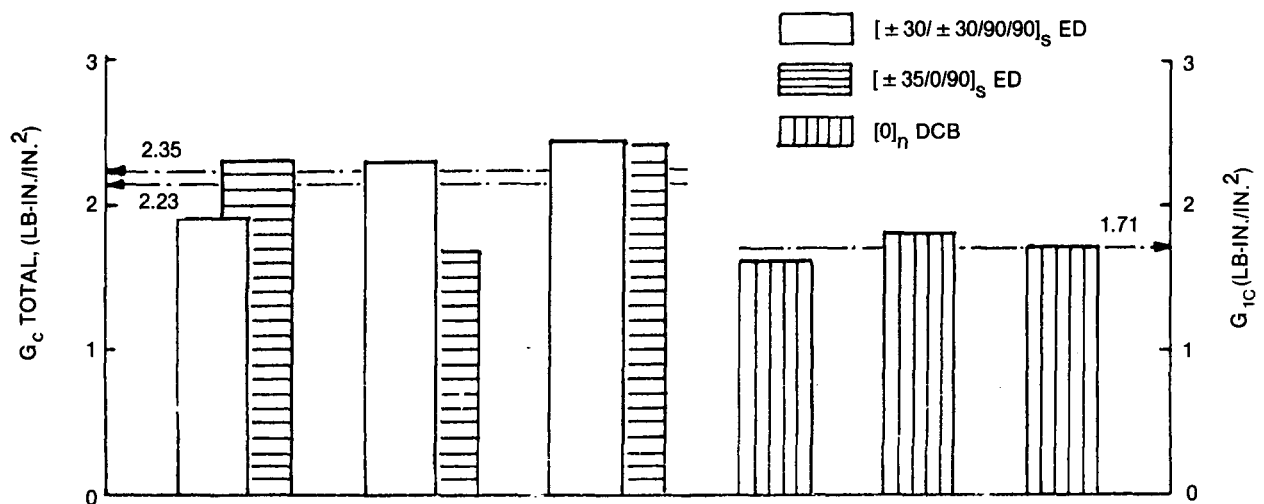
**Figure 51. 1808I/IM6 Fracture Toughness**

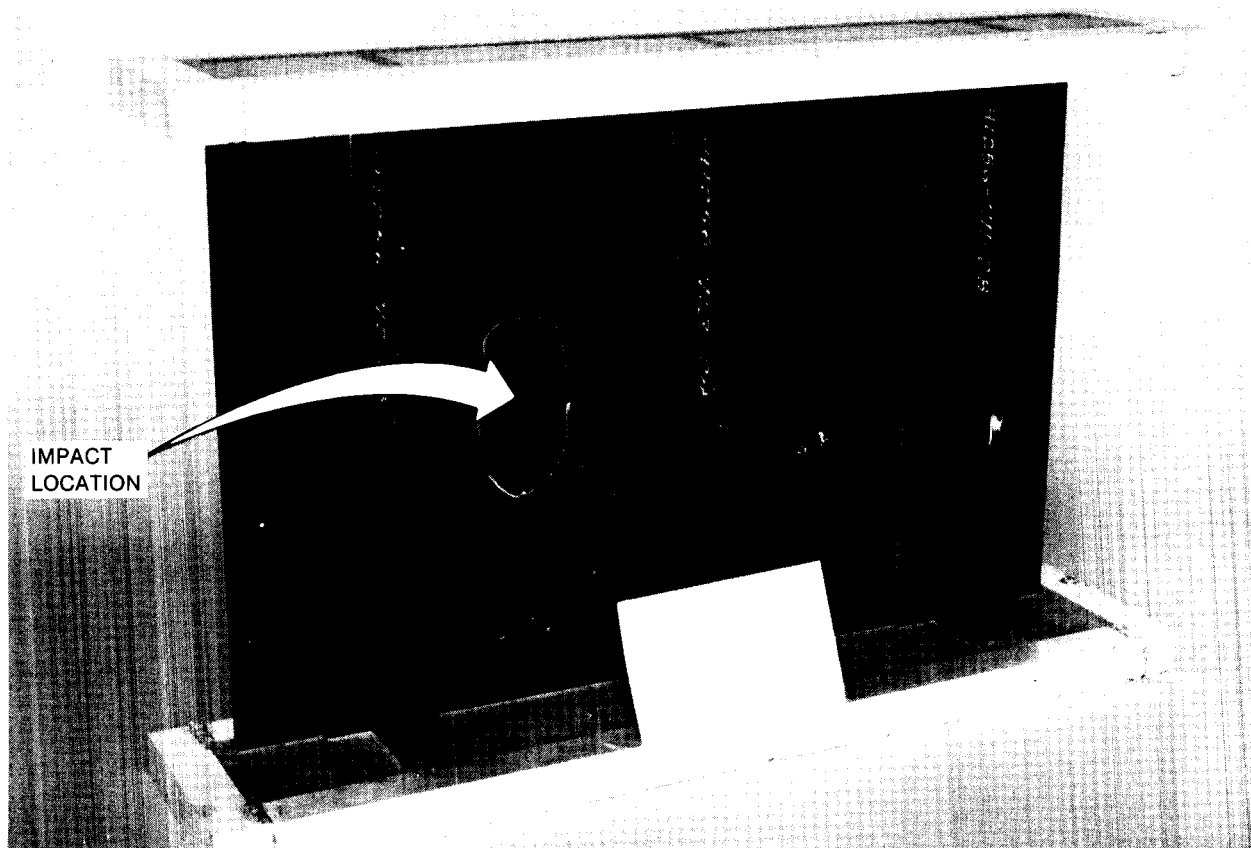
**Figure 52. Three-Stringer Panel B1 After Compression Test (Midbay Impact)**

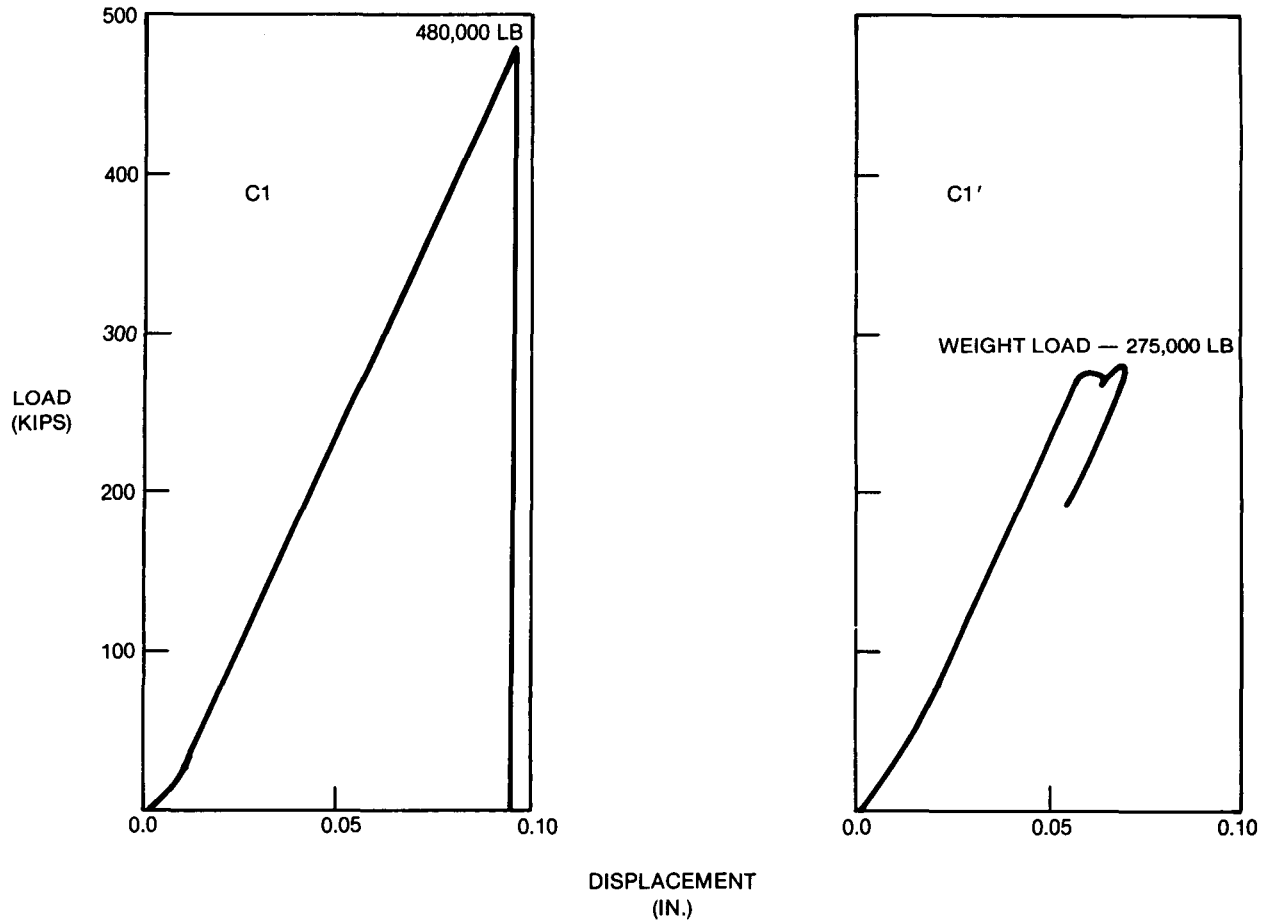
**Figure 54. Compression-After-Impact Test — Three-Stringer Panels C1 and C1'**

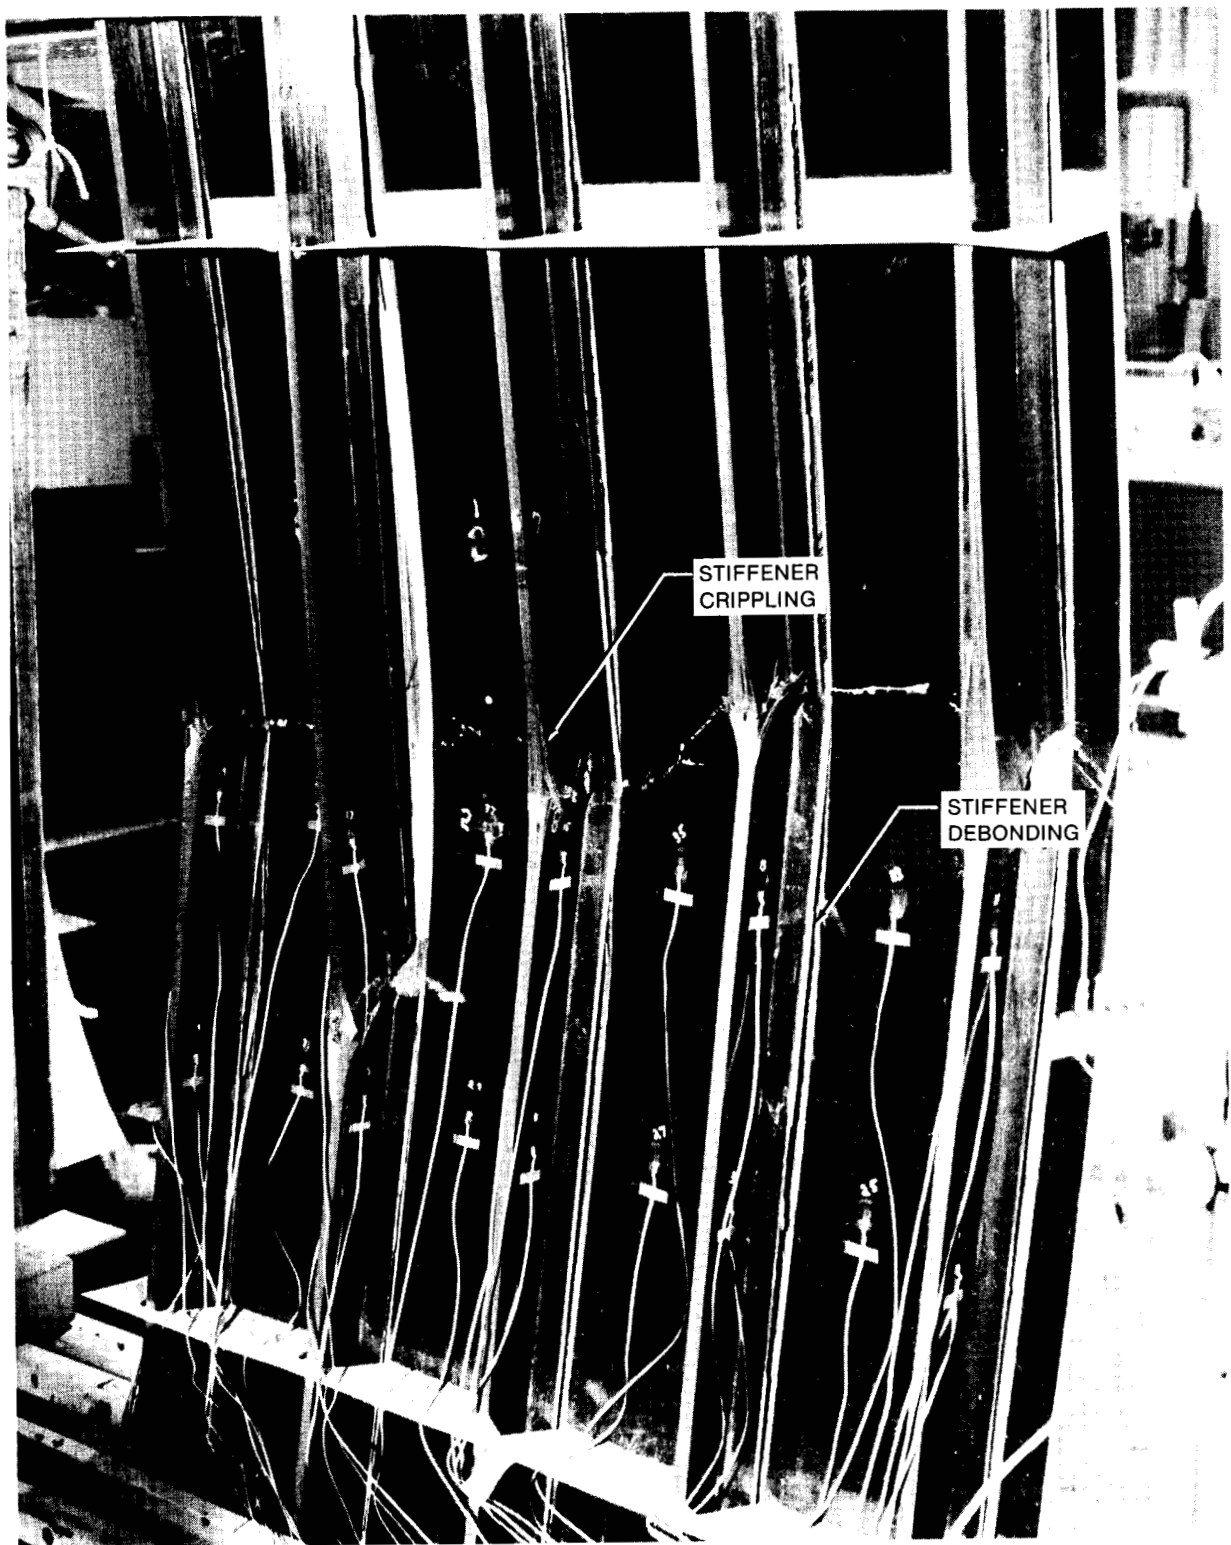
Figure 55. Five-Stringer Panel 5D-1 Compression-After-Impact Test
